LANDTEK LIMITED

April 4, 2016
File: 15014

**Re.: Site Slope Reconstruction for Proposed Columbia International School Residence
925 Main Street West, Hamilton, Ontario**

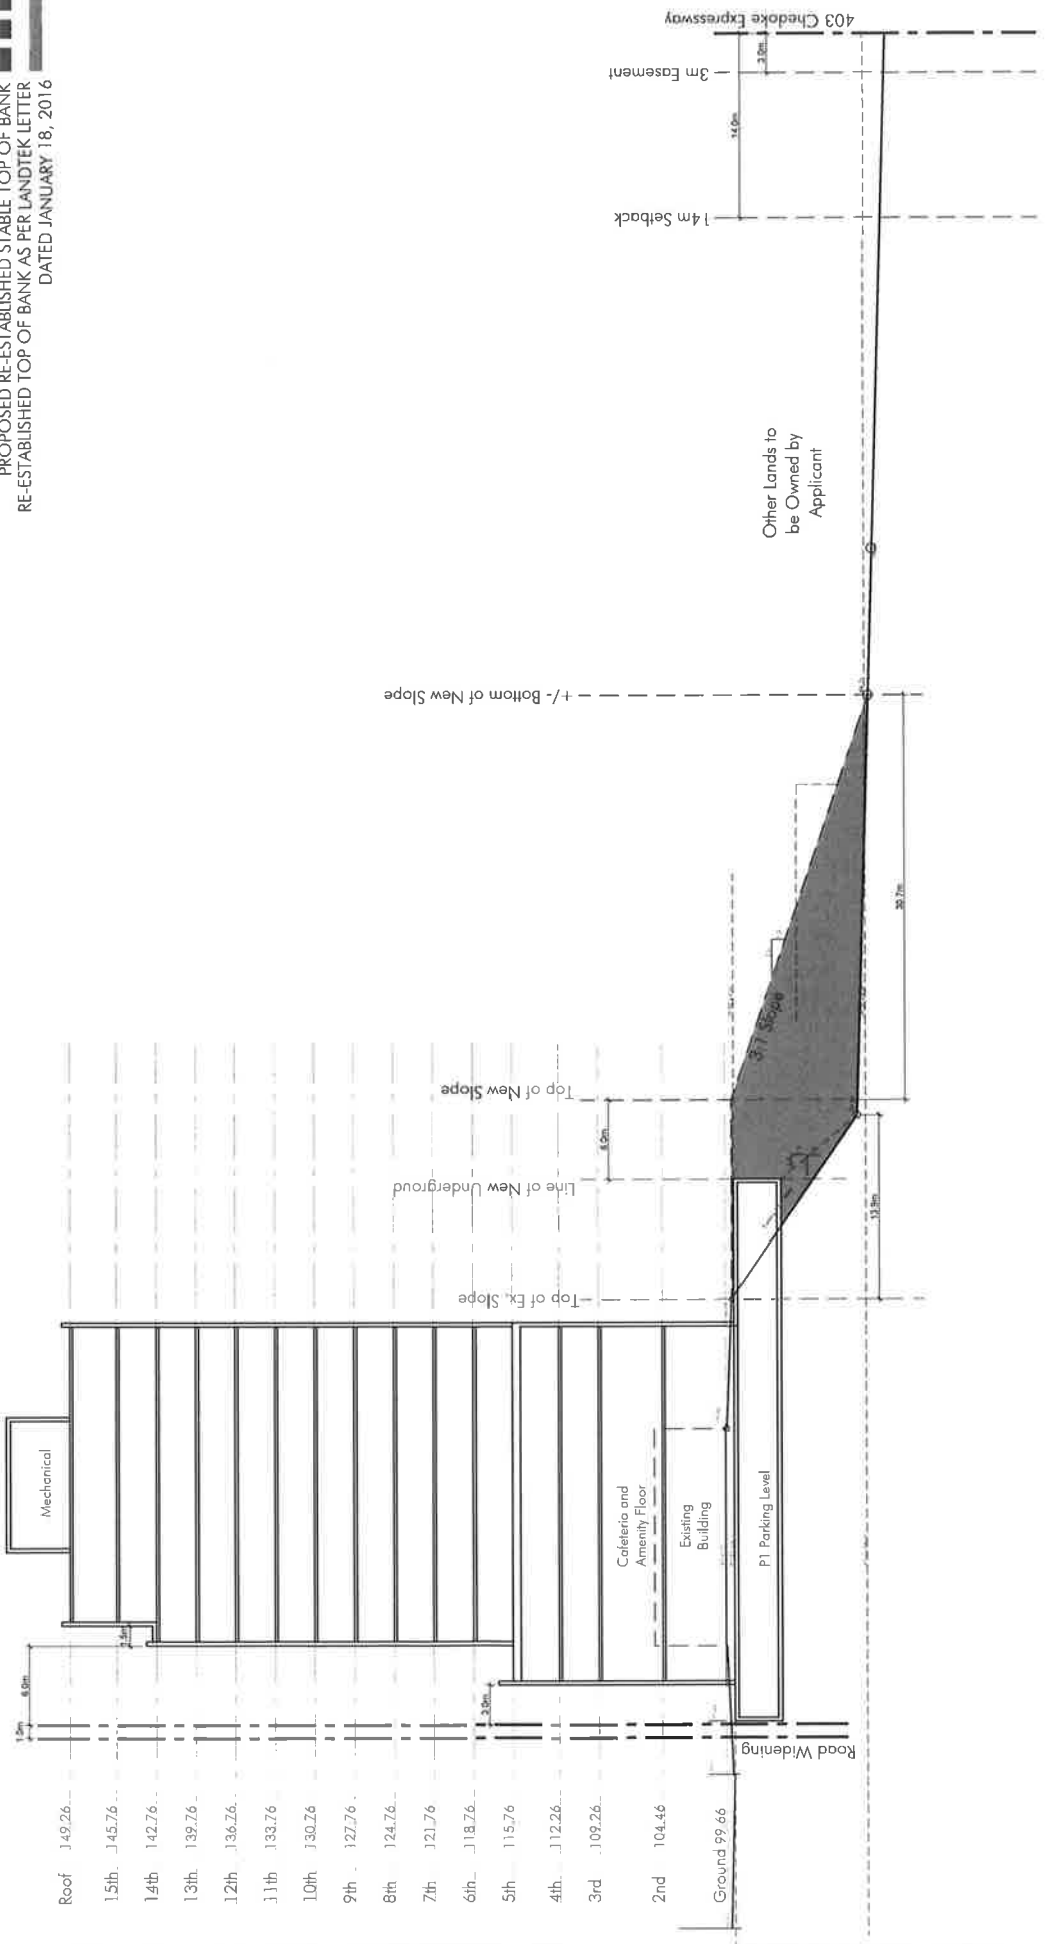
Site Section
 March 10, 2016

EXISTING TOP OF BANK PER SURVEY
 PROPOSED RE-ESTABLISHED STABLE TOP OF BANK
 RE-ESTABLISHED TOP OF BANK AS PER LANDTEK LETTER
 DATED JANUARY 18, 2016

Columbia International College
 925 Main St. West,
 City of Hamilton, Ontario

subject slope such that the rear (south) foundation wall of the underground parking level will be constructed with a 6 m setback from the proposed new, to be constructed, top of slope.
